**NOTCH SENSITIVITY OF FATIGUE BEHAVIOR OF A Hi-NICALON/SiC CERAMIC COMPOSITE WITH
AN OXIDATION INHIBITED MATRIX AT 1200°C IN AIR AND IN STEAM**

THESIS

AIR FORCE INSTITUTE OF TECHNOLOGY

March 2011

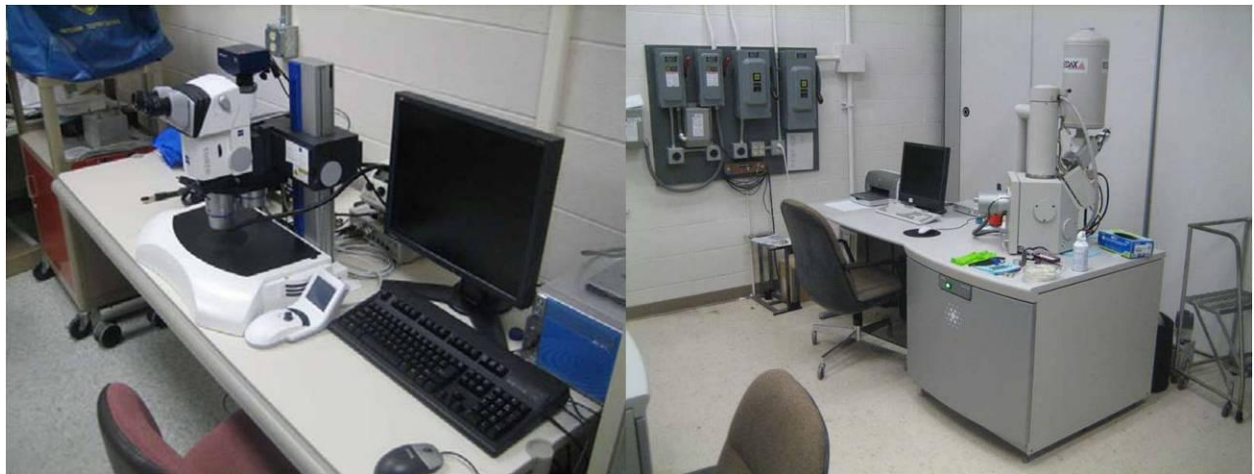
Figure 6: Zeiss optical microscope (left) and Quanta 200 scanning electron microscope (right) used in microstructural characterization

In order to characterize the microstructure of the tested specimens, a Zeiss Discovery V12 stereoscopic optical microscope was used (Figure 6). Photos were taken of each side of the

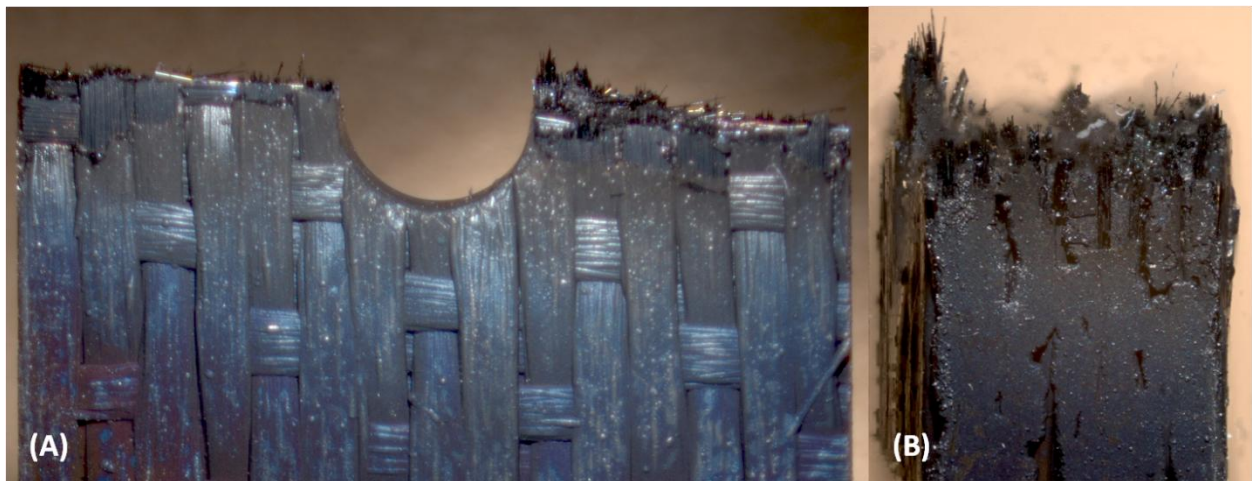
Figure 41: Optical micrographs of the fracture surfaces produced in tensile test to failure conducted at 0.05 mm/s at 1200°C in air on specimen 48.

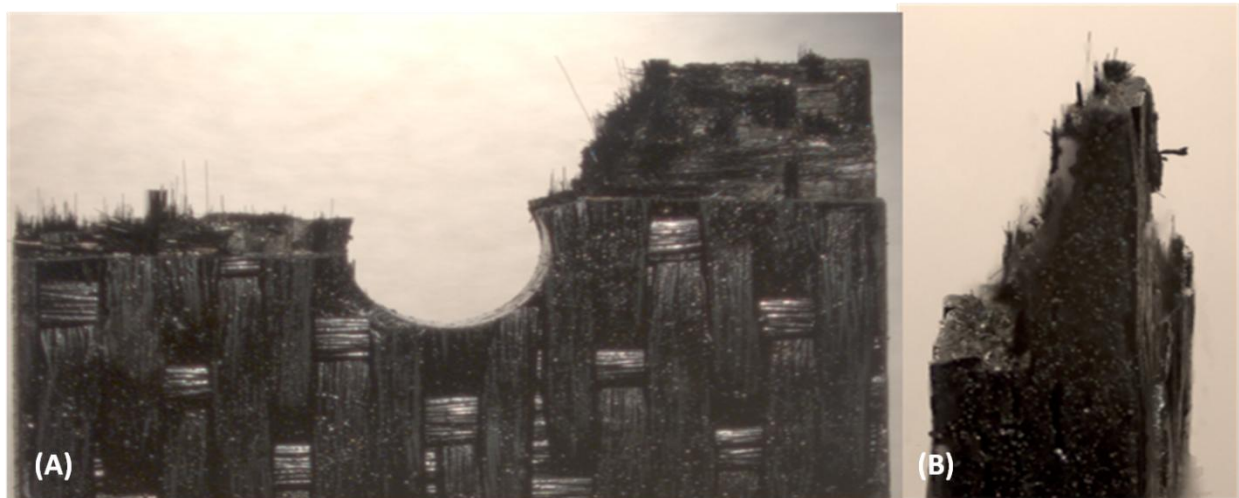
Figure 46: Optical micrographs of the fracture surfaces of specimen 42 tested in fatigue at 0.1 Hz in air at 1200°C. $\sigma_{\max} = 140$ MPa, $N_f = 51,238$, $t_f = 142.3$ h

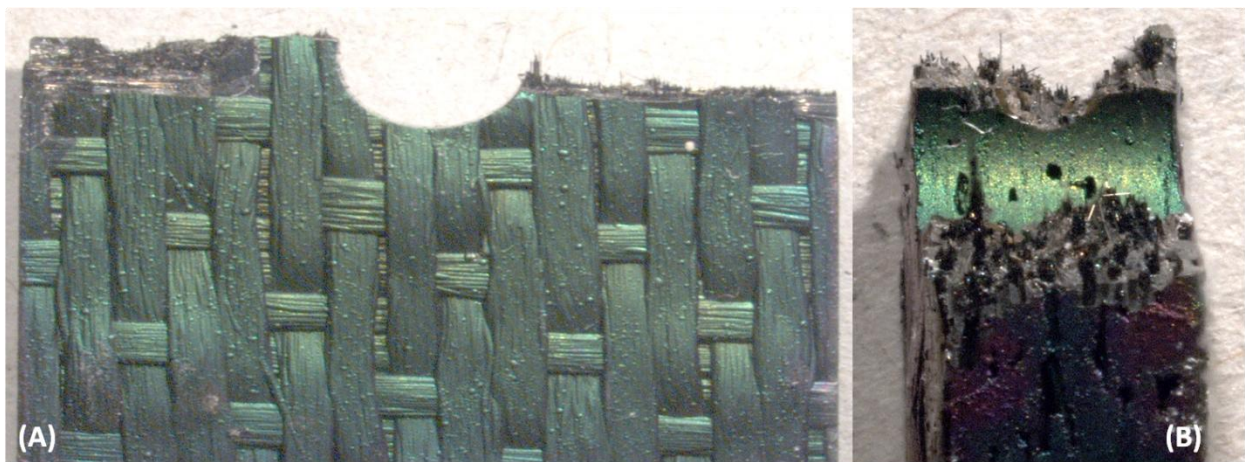
Figure 62: Optical micrographs of the fracture surfaces of specimen 46 tested in fatigue at 10 Hz in steam at 1200°C. $\sigma_{\max} = 140$ MPa, $N_f = 26,485$, $t_f = 0.7$ h
